## Coastal Erosion Induced Landslide in South Orange County

Katie M. Farrington, M.Sc., PG, CEG,<sup>1</sup> Greg P. Silver, M.Sc., PE, GE,<sup>2</sup>  
Ashley A. Varni, M.Sc., PE<sup>3</sup>

### ABSTRACT

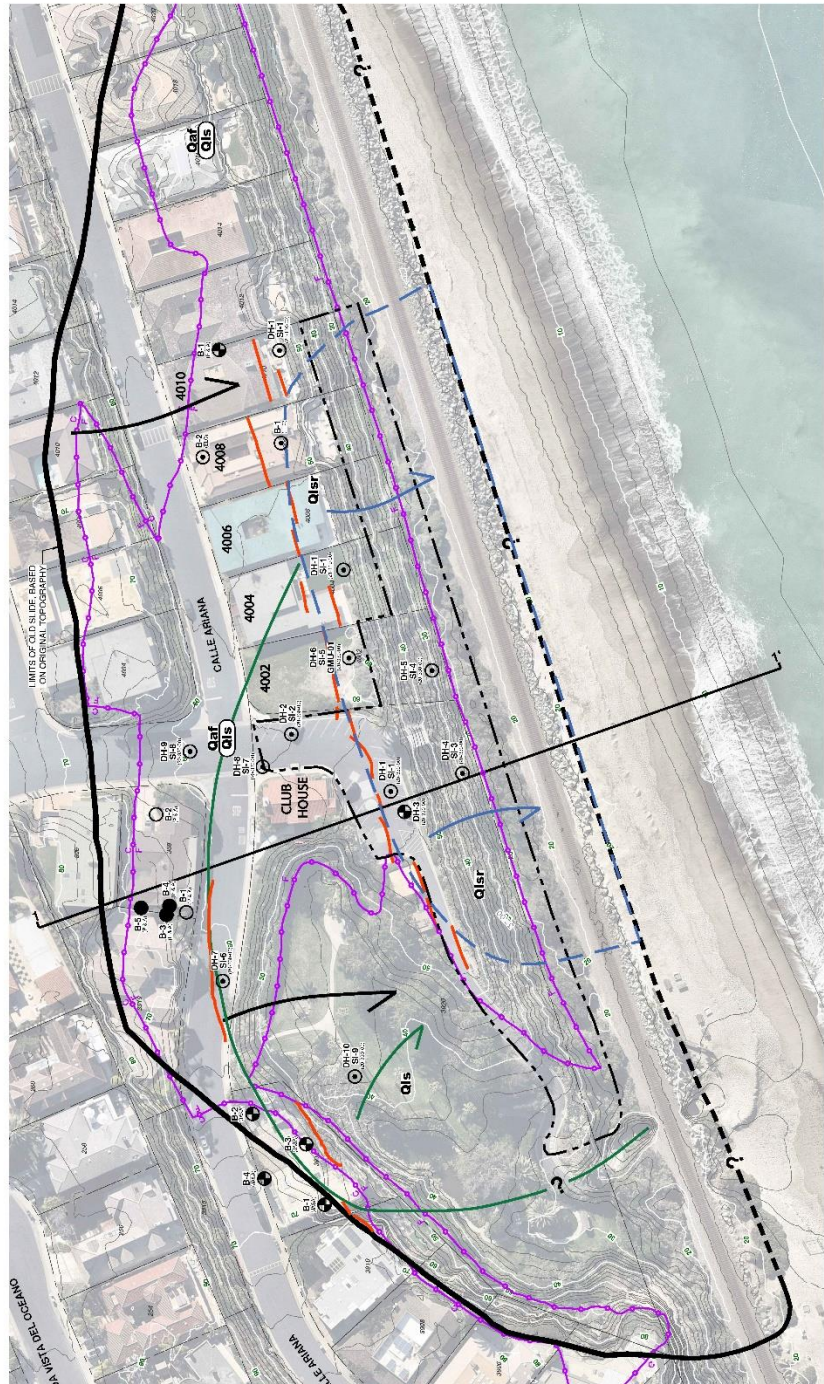
Figure 1. Geotechnical Map

The active landslide addressed in this case study is approximately 800 feet long as measured along the coast, and encompasses the Cyprus Shore Community Association common property, several private residential homes, and the railroad track below and to the west of the community. Existing improvements within the common area portion of the site consist of the community clubhouse, clubhouse parking lot, public restrooms, a paved beach access road, a community park with pond, a view deck over an operations and supply storage room, and City owned and maintained underground sewer lift station and associated utility house. To the south of the common area within the limits of the reactivated portion of landslide are one undeveloped single-family lot (4002 Calle Ariana) and five single-family residential lots with single-family homes and associated improvements (4004, 4006, 4008, and 4010 Calle Ariana). See Figure 1 – Geotechnical Map.

cracking was observed to extend from the northern side of the parking lot and extended southward through the parking lot area and through the adjacent lots at 4002, 4004, and 4006 Calle Ariana. In addition, areas of the concrete curb along the paved beach access road appeared to be pulling away near the public restroom building. Generally, this cracking trended in a roughly north/south line about parallel with the top of the slope (i.e., parallel with the coastline). Cracking is shown on Figure 1.

GMU continued to monitor the cracks from October 2020 to July 2023 and observed the cracking progressively growing in width and length at a slow rate coinciding with an increase in landslide movement and limits. By the completion of the stabilization measures in July of 2023, cracking had expanded to the east, south and north. The observed cracking ranged from minor cracks at the southern end of the landslide with less than an inch of separation near residences 4010 and 4008 Calle Ariana and increased to the north with open cracks and down dropping within the vacant lot at 4002 Calle Ariana and the clubhouse parking lot area of up to about 2 feet. In addition, the residences at 4004 and 4006 Calle Ariana had significant damage to the homes and were red tagged. Further to the east, cracking was observed in Calle Ariana above (i.e., east of) the park area and within houses adjacent to the park at 3912 and 3910 Calle Ariana and 308 Avenida de las Palmera. This cracking has been observed to have up to about 1 inch separation and some down dropping of up to about two inches.

approximately 200 feet north of the community's public restroom to about 4010 Calle Ariana. As discussed in more detail below, GMU inclinometer data confirmed the landslide movement was occurring at a depth of about 0 to 6 MSL with the toe of the failure at the coastal interface where beach erosion and wave action is occurring. The limits of the initial reactivation are shown on Figure 1 – Geotechnical Map and Figure 3 – Cross Section.

As the landslide movement progressed, the active portion of landslide expanded to the east and to the north encompassing the park area, portions of Calle Ariana, and portions of Avenida de las Palmeras. The expansion of the landslide is consistent with our geologic model and predictions made by our slope stability analyses. The limits of the secondary reactivation are shown on Figure 1 – Geotechnical Map and Figure 3 – Cross Section.

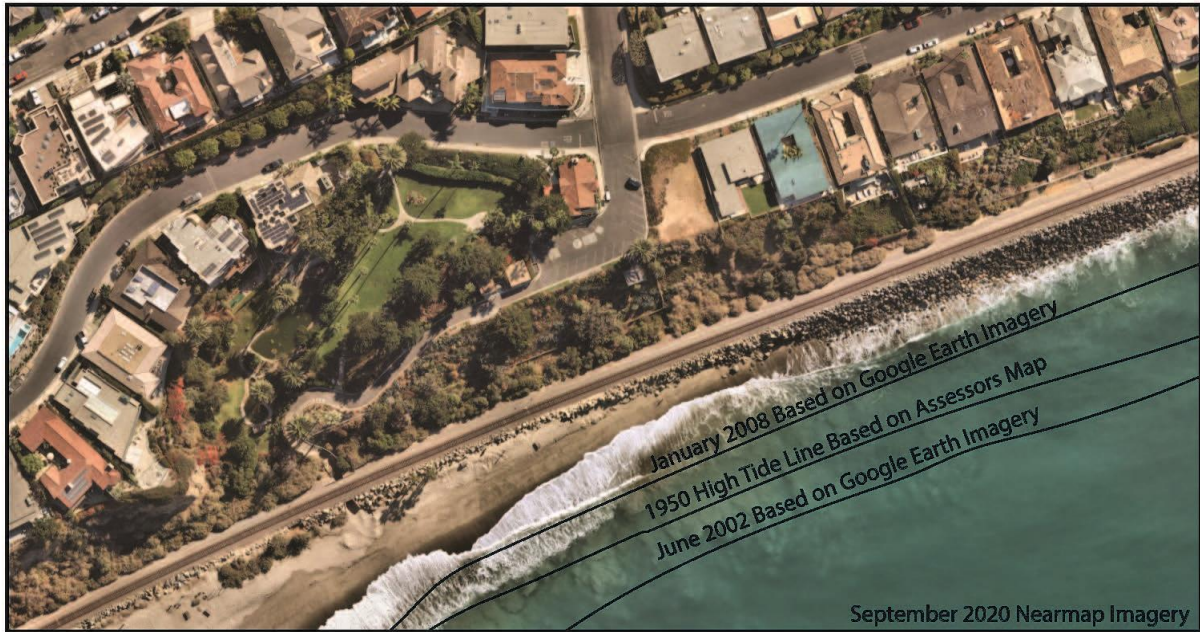
*Figure 2a. September 2020*

It is our understanding, based on conversations with the community's representatives as well as City representatives, that the beach area immediately west of the cracking and landslide was significantly eroded following a King Tide event in July of 2020. Based on field observations, historical aerial review, and comparison of topographic maps obtained from the County of Orange, the beach appears to have lost upwards of 15 to 20 vertical feet of sand just west of the railroad tracks resulting in the loss of an approximately 115-foot-wide beach when compared to the 1950 assessor high tide map. The beach loss appears to be gradual over the last couple of decades with fluctuations in the width of the beach to the west of the Cyprus Shore Community Association (i.e., periods of sand erosion and periods of sand deposition). However, sand erosion has increasingly dominated, and almost complete loss of the beach adjacent to the railroad tracks occurred during the King Tide event of 2020. Figure 2 shows a comparison of high tide marks as well as select aerial photos.

*Figure 2. Aerial photograph comparisons a) high tide lines overlain on September 2020 aerial photograph, b) Google Earth imagery dated April 2013 showing an approximately 150 foot wide beach area to the west of the tracks, c) Aerial photograph taken May 2022 showing a section of recently placed rip-rap on the western side of the railroad track.*

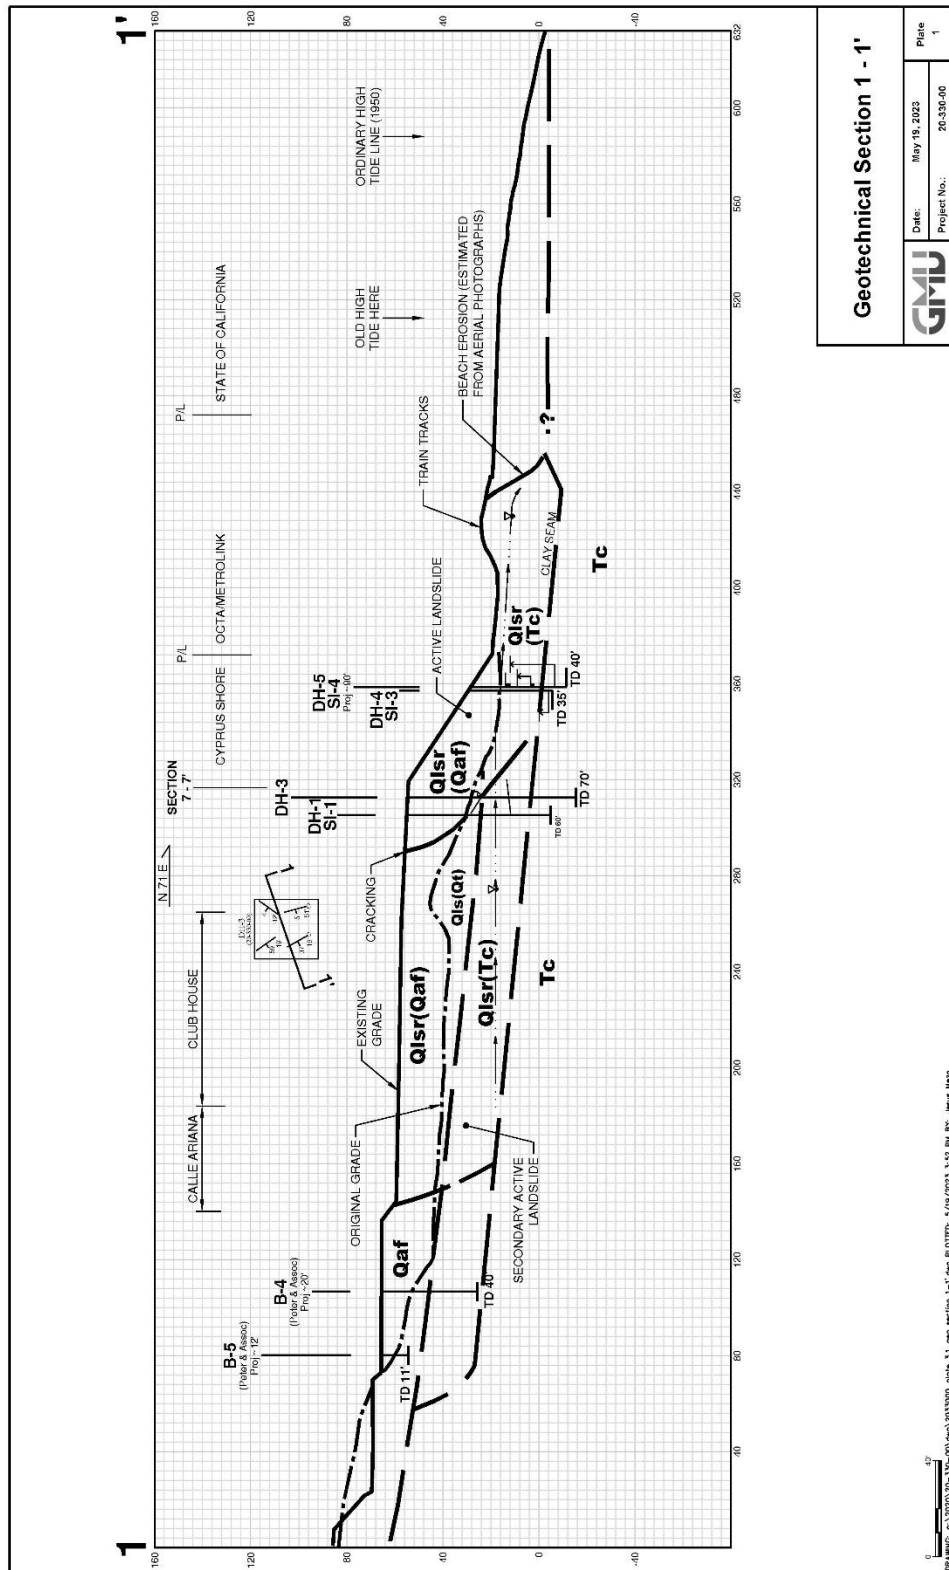
Figure 3. Select Geotechnical Cross Section

The site below the Cyprus Shore Community Association is currently underlain by up to about 35 feet of previously placed artificial fill materials, overlying various depths of landslide materials derived from native terrace deposits and bedrock. The toe of the slide below the railroad tracks and to the west of the tracks is overlain by terrace deposits and beach sand deposits. The landslide materials are overlying moderately hard to hard, unoxidized, massive siltstone and claystone bedrock materials of the Capistrano Formation (See Figure 3 – Geotechnical Cross Section).

Groundwater is present within the site and was encountered during our subsurface investigations. In order to determine a best fit groundwater model for our geotechnical analyses, eight of the inclinometers installed by GMU were converted to standpipe piezometers. In addition, two grout-in-place vibrating wire piezometers were installed within one of the inclinometers at depths of 15 feet Below Ground Surface (BGS) and 25 feet BGS. The groundwater was monitored on a regular basis starting in February 2021 and has continued as of the date of this case study where the inclinometers are still functional (i.e., not sheared off). The groundwater monitoring showed a static groundwater level with no significant upwards or downwards gradients. This generally indicates a static groundwater table within the landslide area. The groundwater table also appears to be controlled by sea level and is consistent across the area being monitored. The exception to this is groundwater below the park area, which is also highly influenced by rainfall. The groundwater level utilized in our geotechnical analyses is shown on our Geologic Cross Section shown in Figure 3.

As previously discussed, a static groundwater level was interpreted and shown on the Figure 3 – Geotechnical Cross Section 1-1'. The level shown on the section was modeled in the stability analyses.

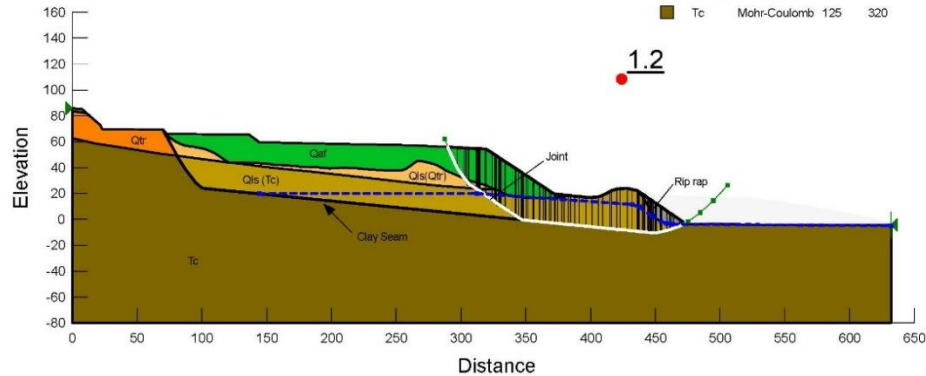
Figure 4. Results of temporary stability analysis

Temporary Analysis, Run 7.0  
Horz Seismic Coef.: 0  
Slip Surface Option: Fully-Specified  
Recent Landslide Failure Surface  
Rip-rap = 245 sq. ft.

In September of 2021, the landslide movement began to accelerate following another King Tide event, which resulted in more beach sand erosion, and emergency temporary stabilization measures needed to be implemented to prevent catastrophic failure of the slope. Based on the results of our geotechnical studies, it was determined that the landslide triggering mechanism was the removal of the beach sand that was buttressing the toe of the landslide. In order to slow down the movement, adding weight back to the toe was the best short term option.

OCTA/Metrolink began the placement of approximately 12,000 tons of rip-rap in September 2021. The rip-rap placement temporarily stopped the landslide movement. Temporary stabilization measures were again implemented to slow the landslide movement in December 2021 after another King Tide event and in September of 2022 after Hurricane Kay. Adding rip-rap to the toe of the landslide (i.e., west of the existing railroad tracks) within the area where sand was previously eroded resulted in the slowing of landslide movement as shown in Figure 6. This further supports our failure causation model indicating that erosion of the beach sand led to the current landslide.

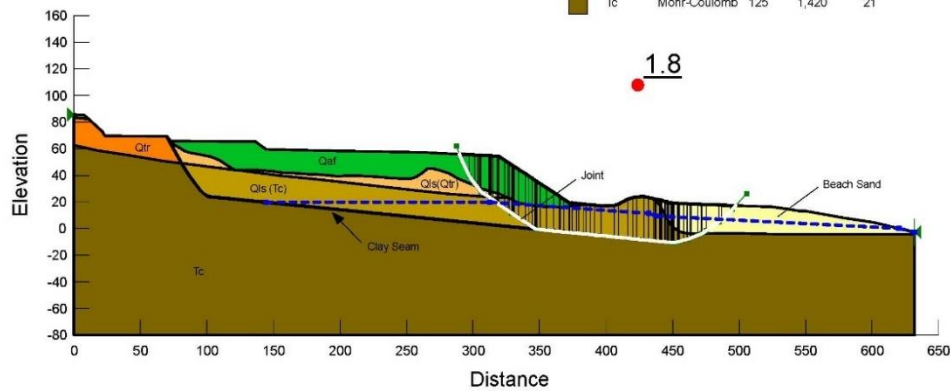
Historical air photo analyses indicated that upwards of 15 to 20 feet of beach sand had been eroded from the toe of the ancient landslide resulting in the loss of up to a 115-foot-wide sand beach. To evaluate the effect of beach sand erosion on the subject landslide reactivation, beach sand was modeled in the analyses. Modeling beach sand back into the analyses (i.e., placing upwards of 15 to 20 feet of beach sand back) indicates static safety factors of approximately 1.8, providing a stable condition. Erosion of the beach sand resulted in a reduction of the static safety factor to 1.0 for the reactivated landslide. This indicates that the beach sand had buttressed the slope, and had it been in place at the toe of the ancient landslide, the reactivated landslide would have been stable. Conversely, the erosion of the beach sand led to the current landslide. These analyses also indicate that our model adequately predicts the observed failure mechanism. In addition, our analysis predicted that the active landslide could expand should enough movement occur, which was verified by additional movement as observed in our inclinometers and field observations. The results of our active landslide analyses for cross section 1-1' are shown in Figure 5.

Figure 5a. Results of stability analyses: Pre-existing condition before beach sand was eroded through initial re-activated portion of landslide.

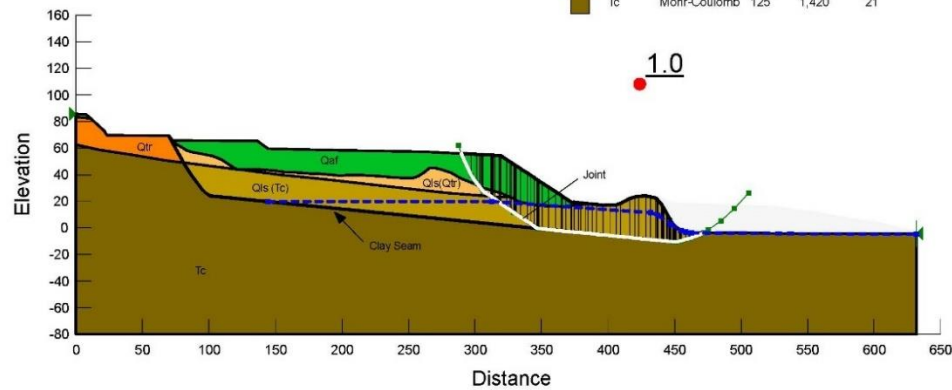
Figure 5b. Results of stability analyses: After beach sand is eroded though initial re-activated portion of landslide

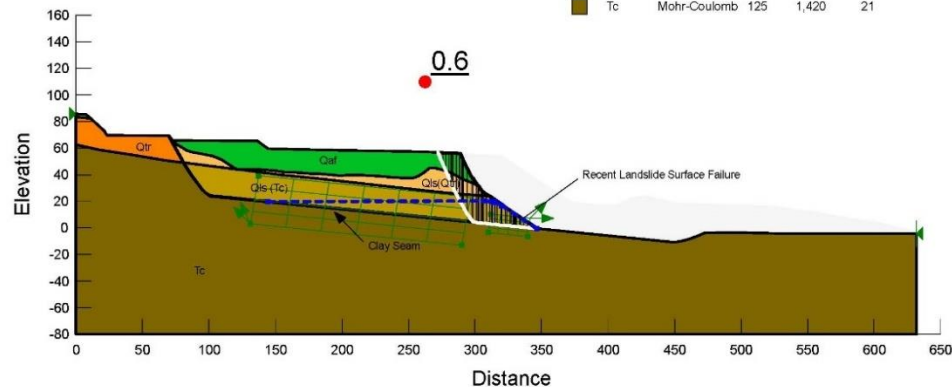
5c. Results of stability analyses: Condition if full failure of initial reactivated failure occurs.
